# Transmission Licence Compliance Review - ElectraNet Pty Ltd

28 September 2016 state-wide power system outage

June 2017

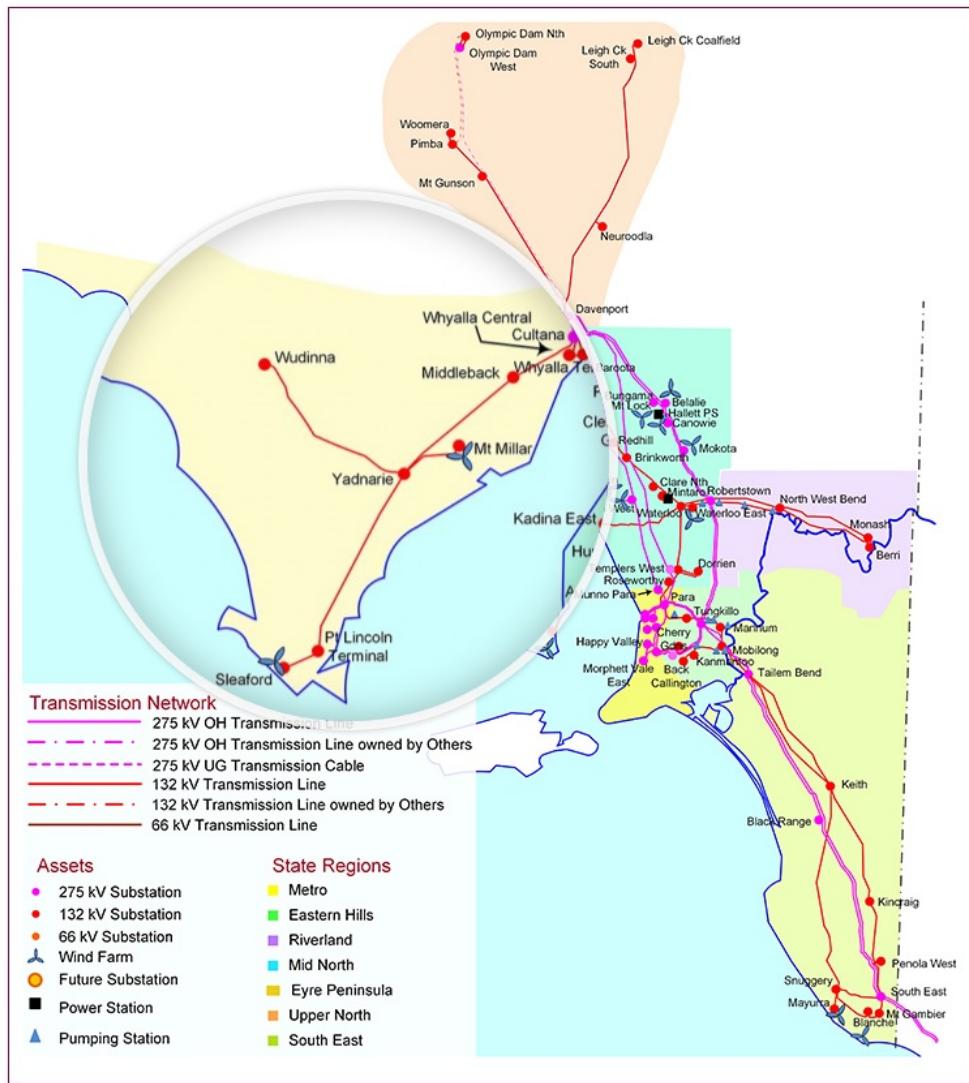
Map 1: Transmission Network Map<sup>12</sup>

ElectraNet's connection at Port Lincoln supplies a 33 kV network which is owned and operated by SA Power Networks. Customers take electricity supply in Port Lincoln for residential, commercial, agriculture, aquaculture and grazing purposes.
